**Weasler**

**50° CONSTANT VELOCITY JOINT  
OVER ANGLE**

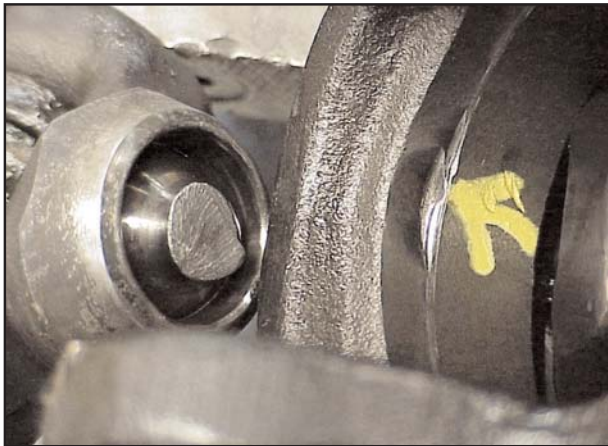
**CENTER HOUSING**

These pictures show damage resulting from contact of the ball and socket with the center housing when operating a 50° constant velocity (CV) joint beyond the 50° design limit. If contact occurs when the driveline is not turning, the center housing will be dented as shown, and the ball may separate. If contact occurs while the driveline is turning, the center housing will have a longer contact area in the same location as the non-operating dent, and the ball may separate.
