**80° CONSTANT VELOCITY JOINT
OVER ANGLE NON-OPERATING**

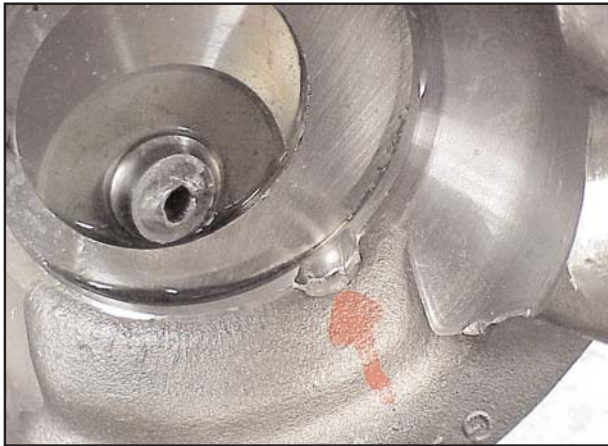
SIDE 1

These pictures show damage resulting from turning an 80° CV beyond the 80° design limit while the driveline is not operating. Both sides of the same center housing are shown. Side 1 shows a sheared pin and indentation where the pin contacted the center housing. Side 2 shows an indentation where the pin contacted the center housing, note the pin did not shear on Side 2. The ball and socket yoke shows an indentation caused when the pin contacted the center housing.
