Weasler

80° CONSTANT VELOCITY JOINT OVER ANGLE OPERATING

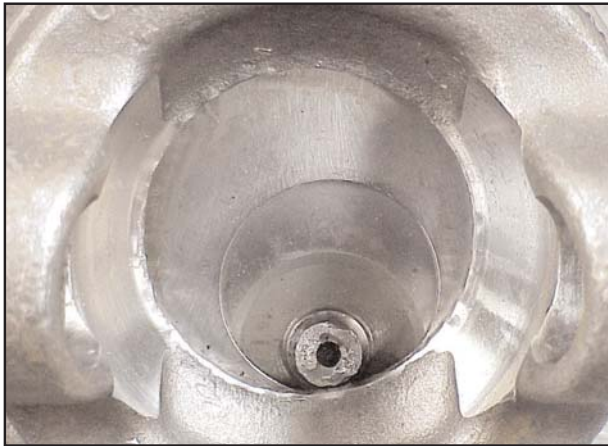
SIDE 1

These pictures show damage resulting from turning an 80° CV joint beyond the 80° design limit while the driveline is operating. Both sides of the same center housing are shown. On side 1 the pin has sheared. On side 2 the pin remains intact but the center housing shows chatter marks from over-angle. This ball and socket yoke has a missing ball, while the retaining ring has been stretched and cracked.
